PHASE I INSPECTION REPORT NATIONAL DAM SAFETY PROGRAM

LOWER HUDSON RIVER BASIN
WATERVLIET DAM
INVENTORY NO. 88
PHASE I INSPECTION REPORT

PHASE I REPORT
NATIONAL DAM SAFETY PROGRAM

Name of Dam: WATERVLIET (I.D. NO. 88)
County Located: ALBANY COUNTY
Stream: LOWER HUDSON RIVER
Date of Inspection: 5 - 6 JUNE 1978

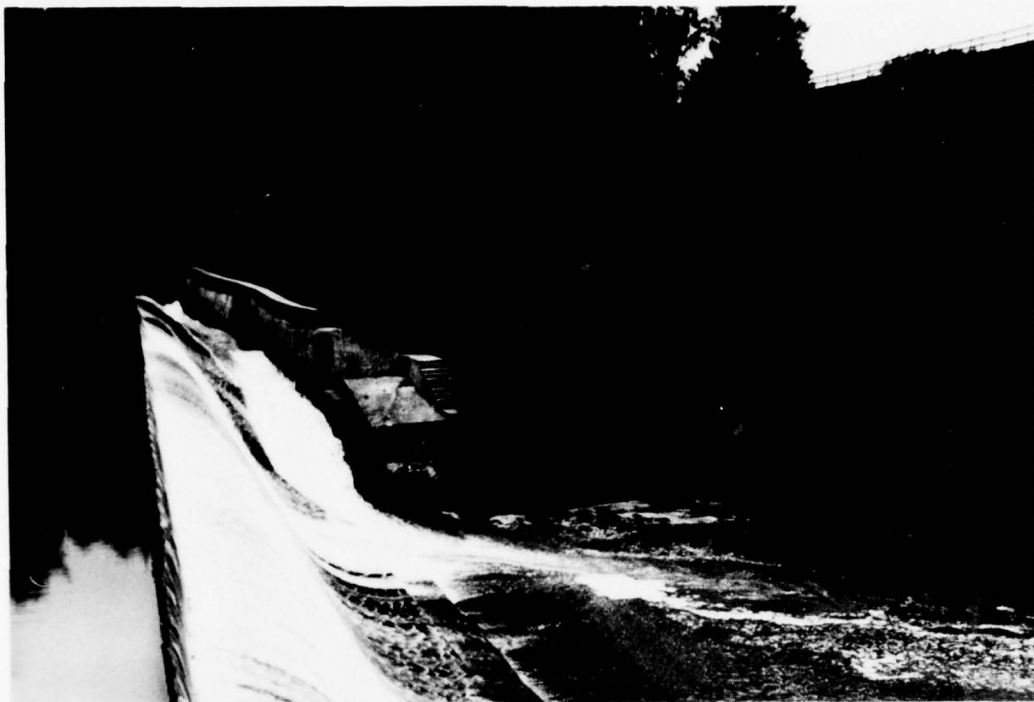
The training wall at the north abutment is in a similar condition with wire mesh exposed from under the eroded gunite layer on the concrete apron in this area.

DOWNSTREAM TRAINING WALL AT NORTH ABUTMENT. NOTE EROSION OF CONCRETE AT BASE OF WALL (SEE NEXT PHOTO), BEDDING PLANES OF SHALE, AND RAILROAD BRIDGE DOWNSTREAM.

b. The concrete training wall and rock erosion at both abutments should be repaired.

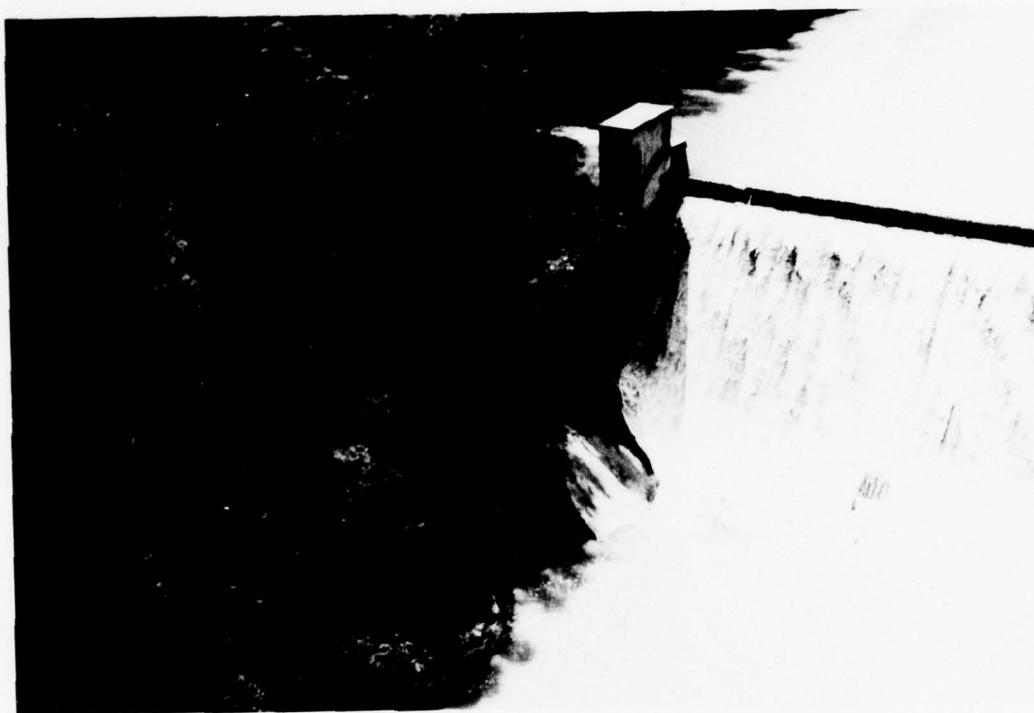
DOWNSTREAM TRAINING WALL AT SOUTH ABUTMENT SHOWING
ENTRANCE TO DAM. NOTE EROSION OF CONCRETE AT BASE OF
WALL (SEE NEXT PHOTO).

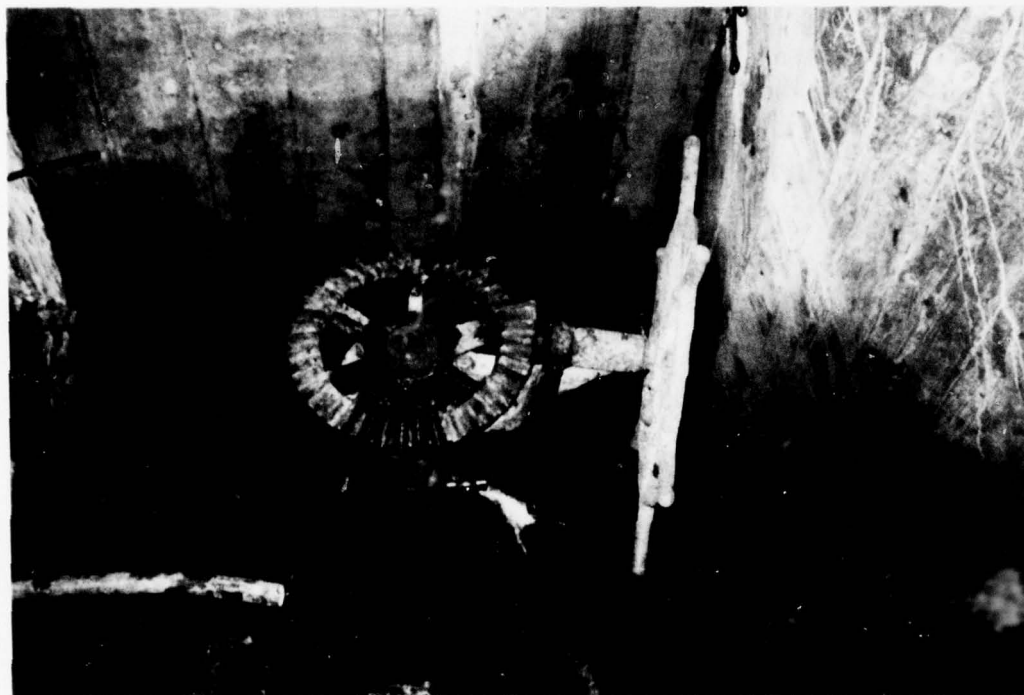
The sluice gate was completely submerged, not allowing for inspection. The gate stand operator was lubricated and appeared to be in operating order, although the gate was difficult to operate. No leakage at the operating stand was observed.

VALVE STEM OPERATOR FOR SLUICE GATE ON LOW
LEVEL OUTLET.

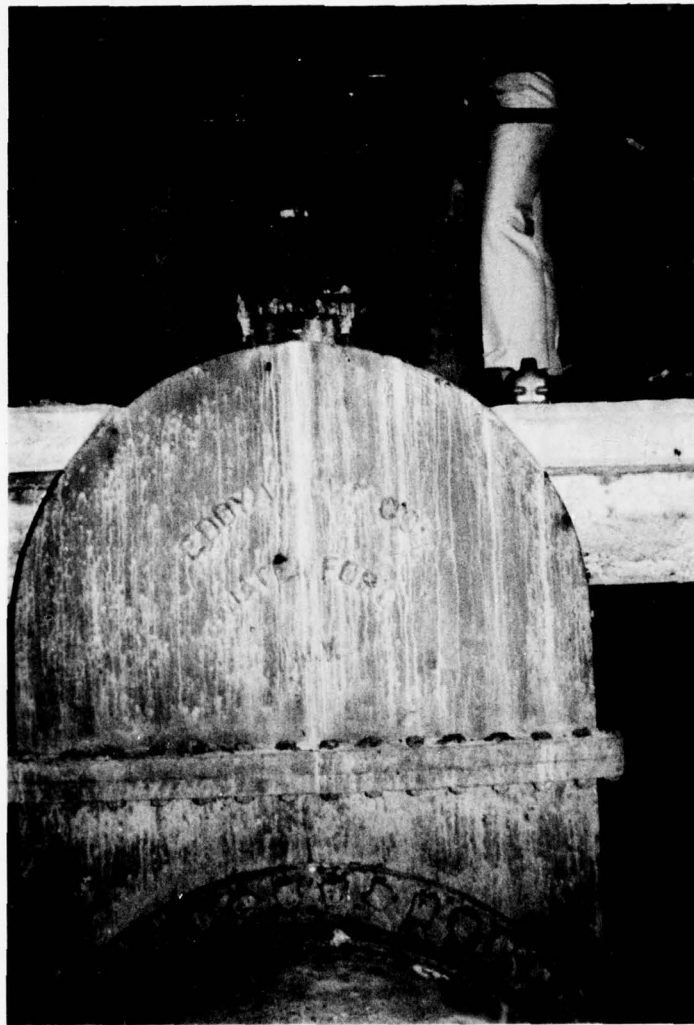
The gate valve appeared to be in good condition. The gear actuator was clean and lubricated and appeared to be completely operable. About 1964, the valve stem was replaced. During the inspection, the packing was slightly damp. Arrangements have reportedly been made to add an electric motor operator to the valve.

48" GATE VALVE ON WATER SUPPLY PENSTOCK FACING DOWNSTREAM

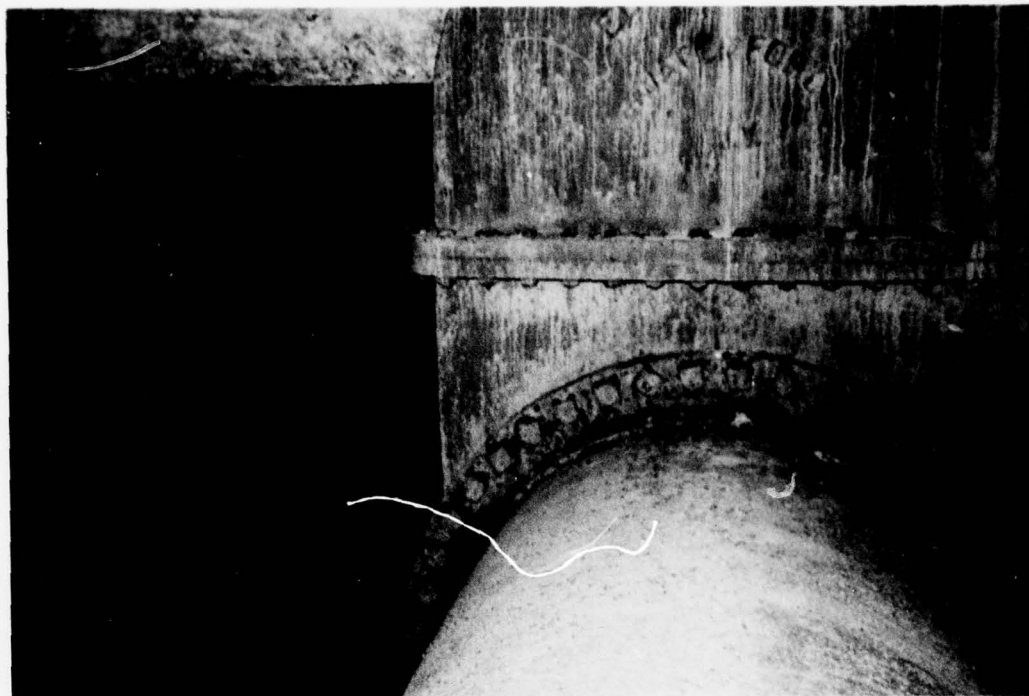
Two 4-foot sections of penstock, adjacent to the cast-iron bends, were observed to have heavy surface corrosion over their entire surface including the flanges. Large amounts of corrosion by-products could be removed from the pipe surface, many of the rivet heads holding the pipe to the flange could be broken from their stems and strips of material could be peeled from the flange, all by hand. Due to the severity of the corrosion,

the depth of the pits from the original surface was indeterminable. Many of the bolts through the flanges were also observed to have severe material losses.

The severe corrosion on fabricated penstock sections within the dam is considered to be a hazardous condition. Sudden rupture of the pipe could cause severe hydraulic impact loading on the downstream face of the dam, the buttress and the buttress foundation.

OVERVIEW OF PENSTOCK DOWNSTREAM OF GATE VALVE
PASSING THROUGH BUTTRESS. NOTE CORROSION ON
PENSTOCK.

The extreme corrosion of the pipe sections is considered to represent an unsafe condition of the dam. The safest course of action would be to completely shut the 48-inch gate valve upstream of the corroded pipe sections until their replacement. However, bearing in mind that the penstock carries the City of Watervliet's only water supply, a recommended alternative procedure would be to close the upstream gate valve so as to substantially reduce the water pressure in the corroded pipe sections and yet provide the water requirements of the city until the replacement is made. If this alternative is elected it is recommended that replacement of the corroded pipe sections be made within 30 calendar days of the date of this report and that surveillance and warning systems be put into effect until replacement has been made.

It is recommended that the remaining penstock sections and fittings within the dam be tested by non-destructive methods, such as ultrasonic testing, to determine their soundness.

e. After the testing and replacement of the required penstock sections, all exposed metal surfaces should be cleaned, primed with a rust inhibitor, and painted with an appropriate coating.

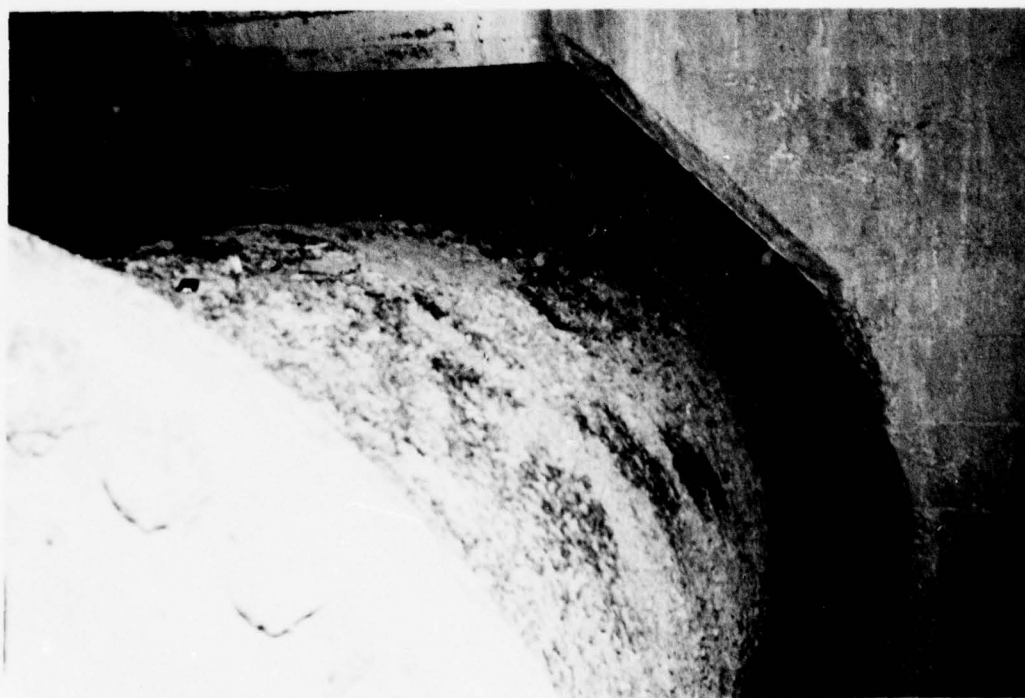
CLOSE-UP OF CORROSION ON PENSTOCK SECTION
PASSING THROUGH BUTTRESS.

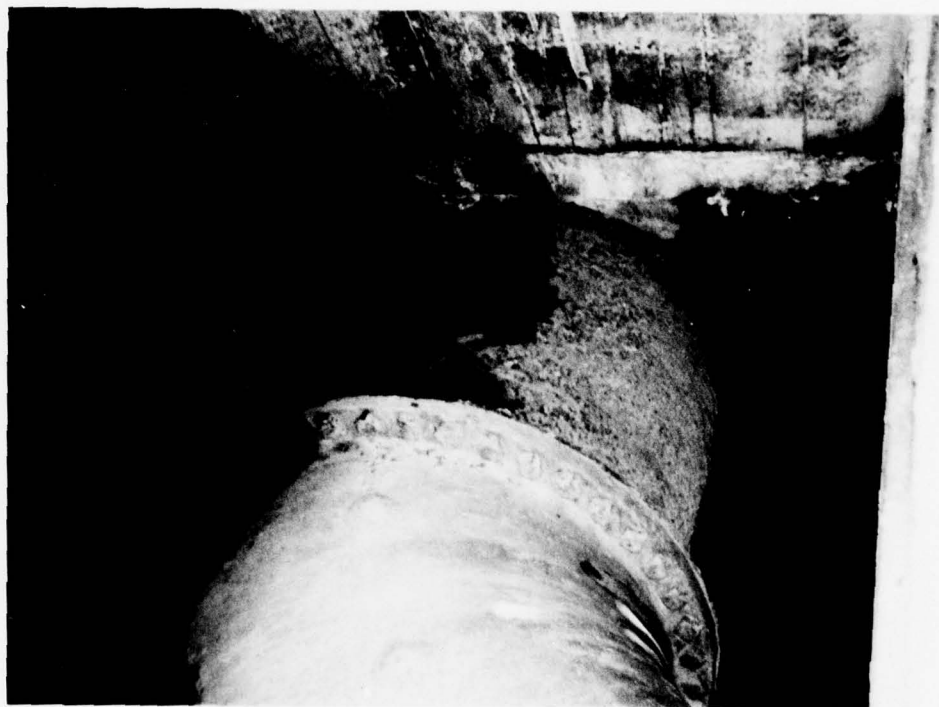
PENSTOCK SECTION THROUGH DOWNSTREAM FACE OF DAM.
ROUGH EDGE ALONG RIGHT SIDE OF PENSTOCK INDICATES
EXTENT OF CORROSION.
